# CASE STUDY #3

## the solution ...

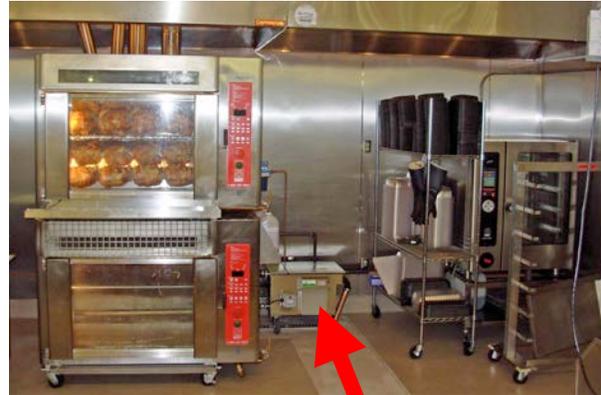
**GOS - 40**

The warehouse chain store contacted Goslyn, LLC and asked for their assistance in dealing with the aforementioned problem and in helping them achieve the above mentioned goals. Goslyn responded by installing, on a test basis, a GOS-40 grease recovery device. The unit (GOS-40) was installed to recover FOG only from the top rotisserie oven (input) while the outlet of the GOS-40 was connected to a water pan drain system.

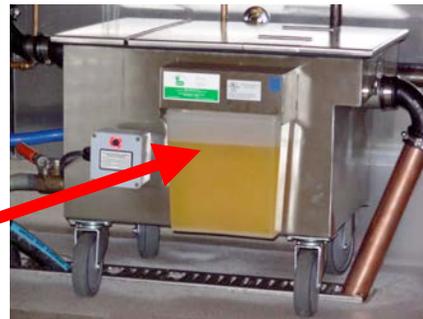
**Recovered FOG / Yellow Grease**

• Test period	7 days
• Number of batches cooked during the 7 day period	25
• Number of birds (chickens) cooked per batch	32
• Total number of birds cooked during the week-long test period	800
• <b>The amount of F.O.G. recovered in the Goslyn – 40</b>	<b>120 lbs / 17.4 gallons</b>
• <b>The amount of F.O.G. NOT being discharged down the deli operation drain from just one rotisserie oven</b>	<b>120 lbs. / 17.4 gallons</b>
• <b>Quality of the FOG / Yellow grease recovered by the GOS – 40</b>	<b>98% -- 99% pure oil ≥ 1% moisture &amp; solids</b>
