CASE STUDY #3

CASE STUDY FOR HIGH SILT EFFLUENT SITUATION

The Pheasant and Quail Pub , Kelowna, BC, Canada

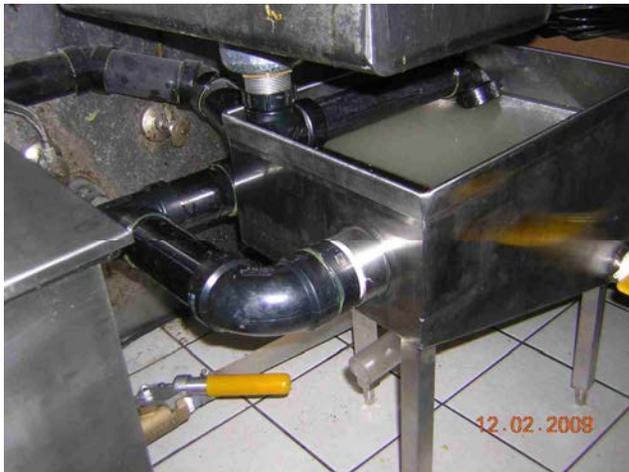
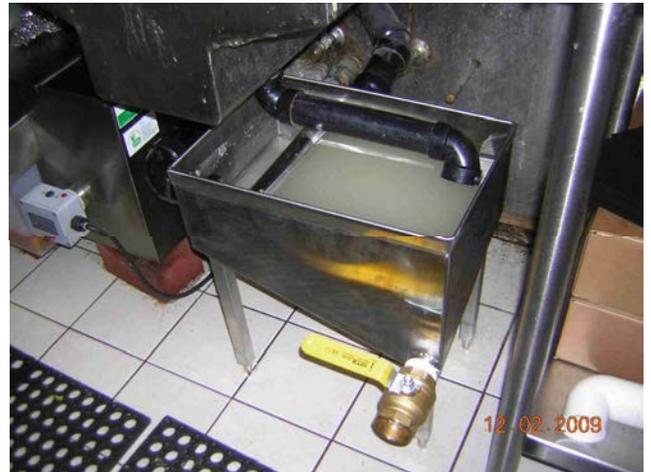
A receiving tank was designed to place between the pre-rinse sink and the Goslyn. This was sized so as to allow the silts to settle out as the effluent passed through but to allow the FOG to spill over an internal weir (along with relatively silt free water). The resulting “clean” effluent was then directed to the Goslyn as before. The base of the receiving tank was sloped at a steep angle to encourage the silt towards the take off valve (1.5” diameter) where it could be easily drawn off as a concentrate and disposed of in the kitchen trash bin.

The receiving tank proved to be highly effective in removing the silt load from the effluent stream and the Goslyn could now work to full efficiency to protect the drain lines
